General Fault (ASB)

Preform Body Fault (ASB)

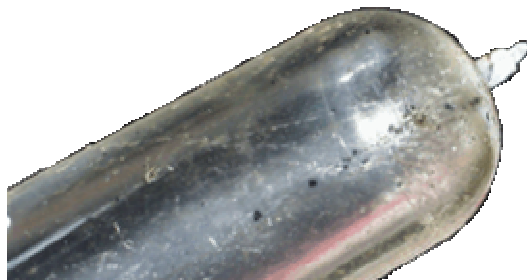
Black Specks

Small black specks of decomposed material appear at random. This fault will be most obvious in the gate area of the preform but could be anywhere.

It is common to see this fault on the first one or two shots after a start-up from cold because decomposed material will have come from the hot runner. **Do not** recycle

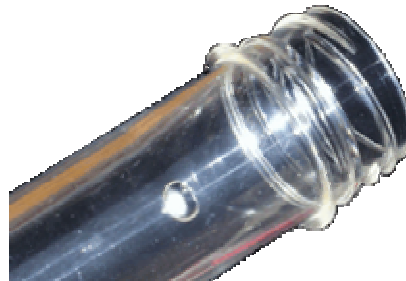
Bubbles - Random Position / Random Cavity

Bubbles of gas appear in the body and / or neck of the preform. The frequency varies, and appear in random positions within random cavities.

This type of bubble is normally associated with a problem that is coming from the injection barrel of the molding machine. The bubbles are then being distributed at random to each cavity.

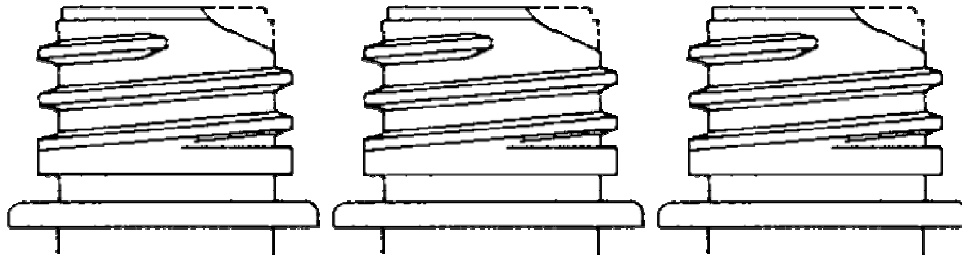
Short Shot (All Cavities)

The top of the preform neck is missing due to underfilling of the cavity. This may appear on [one cavity only](#) or may be on all. When it is a severe case on one cavity only, this may cause flashing on other cavities.

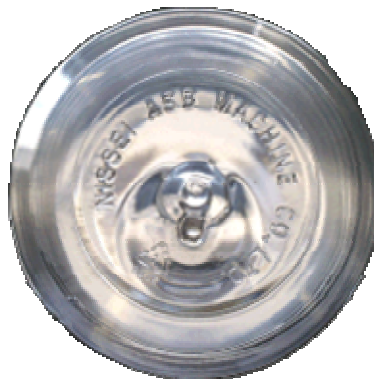
Gate Off Center

The gate of the preform is not in the center of the bottle base. There are many possible causes of this fault.

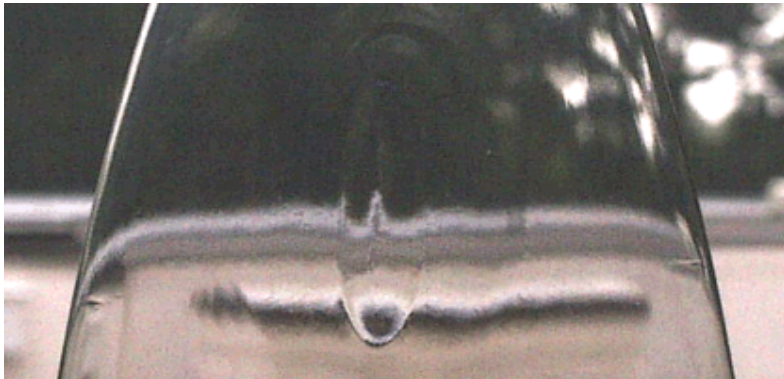
Lensing (Fisheye)

Description
<p>This fault is more common in containers that do not have optimized stretch blow ratios such as toiletries, cosmetics and pharmaceuticals.</p> <p>These types of containers tend to be heavier than the optimum since the customer has often requested a container with a strong feel. Since a thick preform will give an uneconomic cycle time, it is preferred that the extra weight is added by increasing the size of the preform. However, this in turn, can lead to problems with Lensing.</p>
